ELIOS 2 IN ACTION | SCRUBBER INSPECTIONS

**DRONE REDUCES TIME NEEDED  
FOR SCRUBBER INSPECTION BY  
98%/470 HOURS**

TVA TESTED THE ELIOS 2 FOR THE INSPECTION OF A SCRUBBER AT ONE OF ITS POWER PLANTS AND FOUND THAT IT HELPED KEEP PERSONNEL SAFER WHILE SIGNIFICANTLY REDUCING THE AMOUNT OF TIME REQUIRED FOR THE INSPECTION.

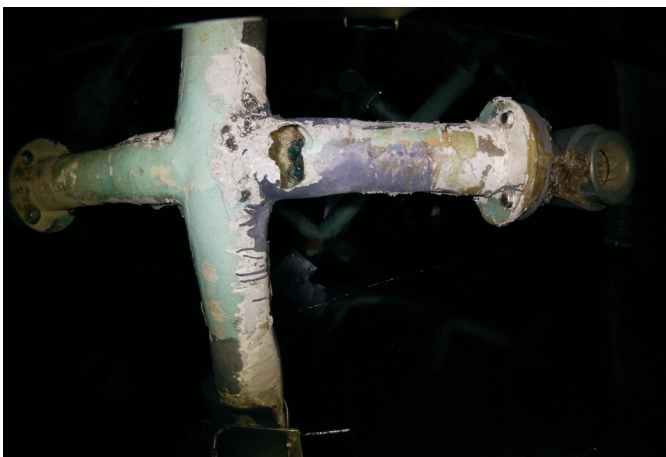
Picture captured by drone during the mission

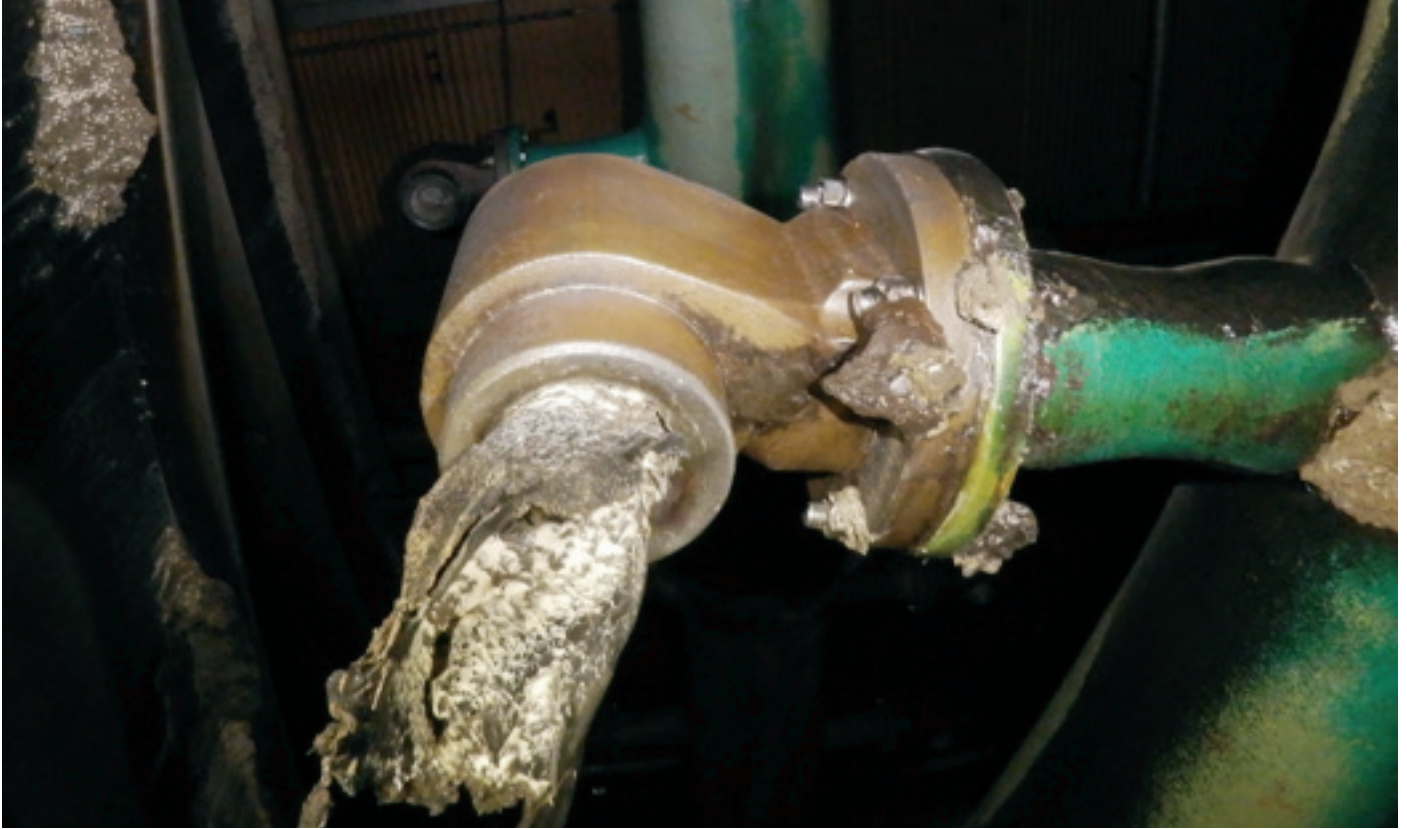
Picture captured by drone during the mission
